Manhole Inspection Summary

Manhole # S23KK1026MH

Insp Date: **11/6/06 3:25 PM**

Location Address: **1125 WOOD HEIGHTS AVE**

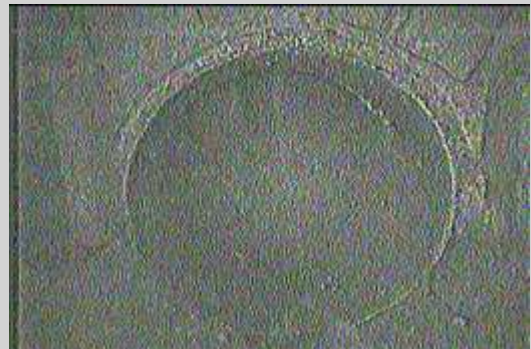
Drop In @ 3 O'Clock

Infiltration: **Evidence** Pipe Seal Cond: **Cracked**

Drop: **Outside** Rod and Bar

Angled: **Yes** Reading: **9.70** (ft.)

Inv Depth: **10.70** (ft.)

Drop Condition: **Open**

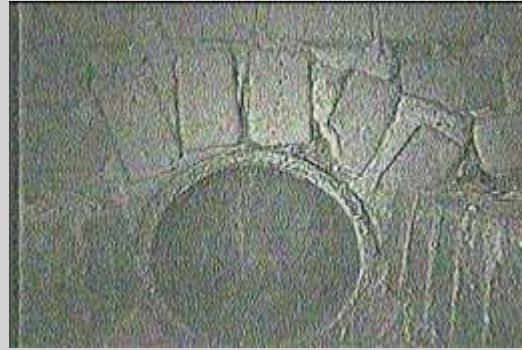
Drop In @ 6 O'Clock

Infiltration: **Evidence**

Pipe Seal Cond: **Cracked**

Drop Condition: **Open**
